Customer MAVI Properties Ltd

Location Llangollen

Acting as Principal Contractor, Knights Construction's Civil Engineering division were contracted to repair the collapsed river wall at the iconic Royal Hotel.

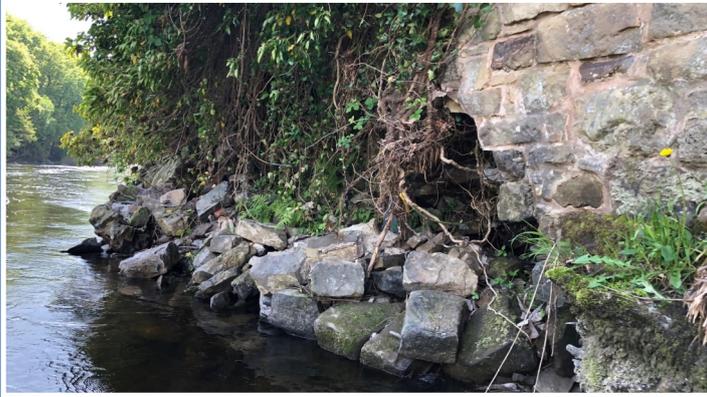
The damage was caused by an extremely bad storm and subsequent high river levels in early 2019. Further erosion exacerbated the damage in the time taken to arrange permits, gain access to the river and manage the demolition of part of a listed building.

Access to complete the works created the biggest challenge. Knights Construction were able to complete the advanced demolition works, required for the next phase of refurbishment to the Hotel, in order to erect a mobile tower crane with a 40m reach. This was fundamental to the safe delivery of the scheme. It allowed materials and safety equipment to be lowered into the river and debris from the collapsed wall to be removed.

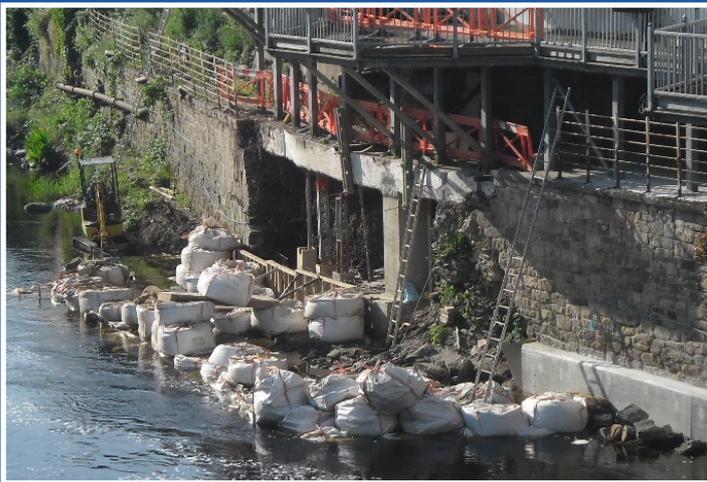
With the vegetation cleared, the true extent of the collapse became apparent. To safely access the work area, large sand bags were placed into the river to stem the flow of water and protect the works from rising river levels.

The loose material was carefully removed from both the wall and the river bed, and the damage assessed in conjunction with the Structural Engineer. A solution was developed which included constructing a 60m section of reinforced concrete foundation and retaining wall, including under-pinning sections of the existing wall. These were anchored into the underlying bed-rock, and in total 120m³ of self-compacting concrete was poured into the retaining structure.

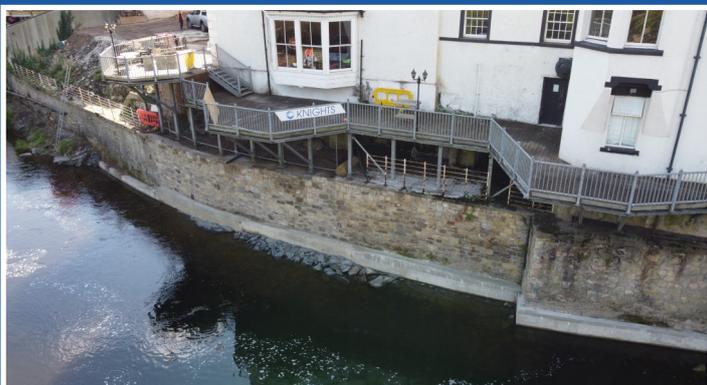
Once the retaining wall was complete, the wall was faced with local stone to ensure it was aesthetically in-keeping with the local area.
